# Manhole Inspection Summary

Manhole # S25CC\_023MH

Insp Date: **2/29/08 10:56 AM**

**Location** Address: **1437 MOSHER ST**

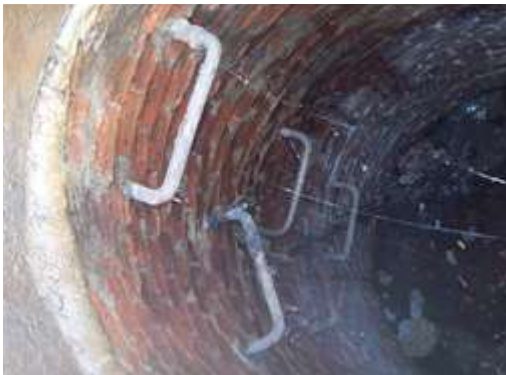
Defect 2

Condition: ☐ Sound ☒ **Cracked** ☐ Root Intrusion ☐ Loose Brick ☐ Deteriorated

Count: **6** Missing: **0** ☒ **Corroded**

corroded steps and cracked chimney/frame adjustment

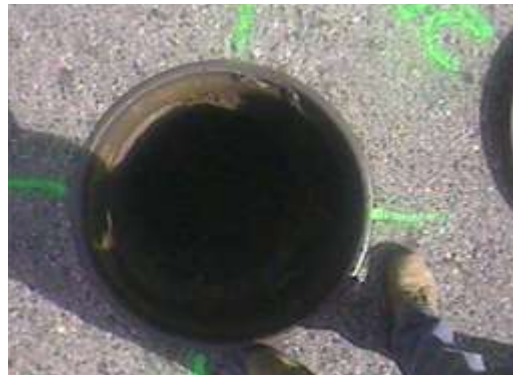
Defect 1

Offset: **1** (in.)

frame offset

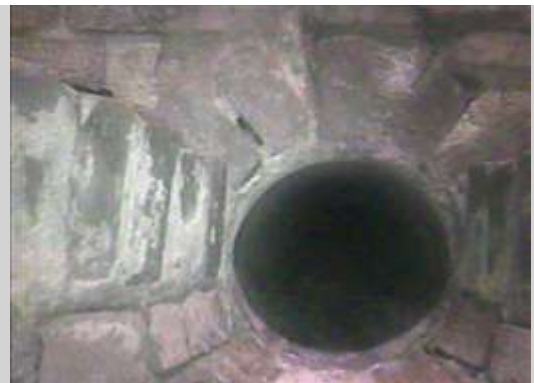
12 O'Clock Outflow

8 in. Circular Gravity Sewer  
Pipe Out @ 12 O'Clock

Infiltration: **None** Pipe Seal Cond: **Sound**

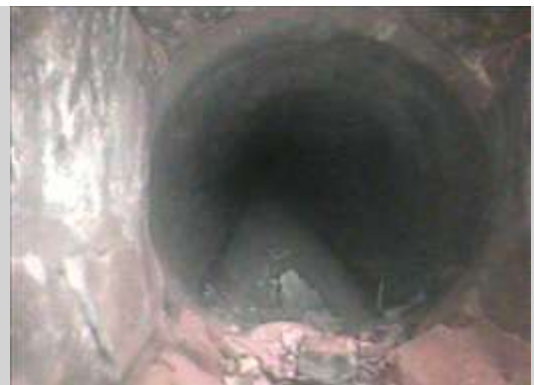
3 O'Clock Inflow

8 in. Circular Gravity Sewer  
Pipe In @ 3 O'Clock

Infiltration: **None** Pipe Seal Cond: **Sound**

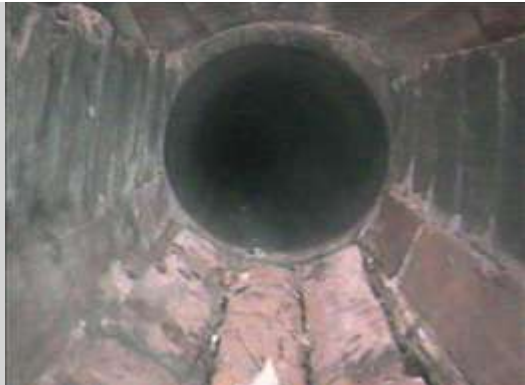
6 O'Clock Inflow

Infiltration: **None** Pipe Seal Cond: **Sound**

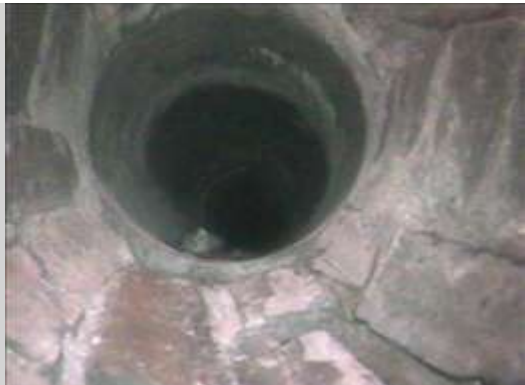
9 O'Clock Inflow

Infiltration: **None** Pipe Seal Cond: **Sound**
